Wetlands Research Program Technical Report WRP-RE-12

Monitoring Study, Eastern Neck Island National Wildlife Refuge

Monitoring Study, Eastern Neck Island National Wildlife Refuge (TR WRP-RE-12)

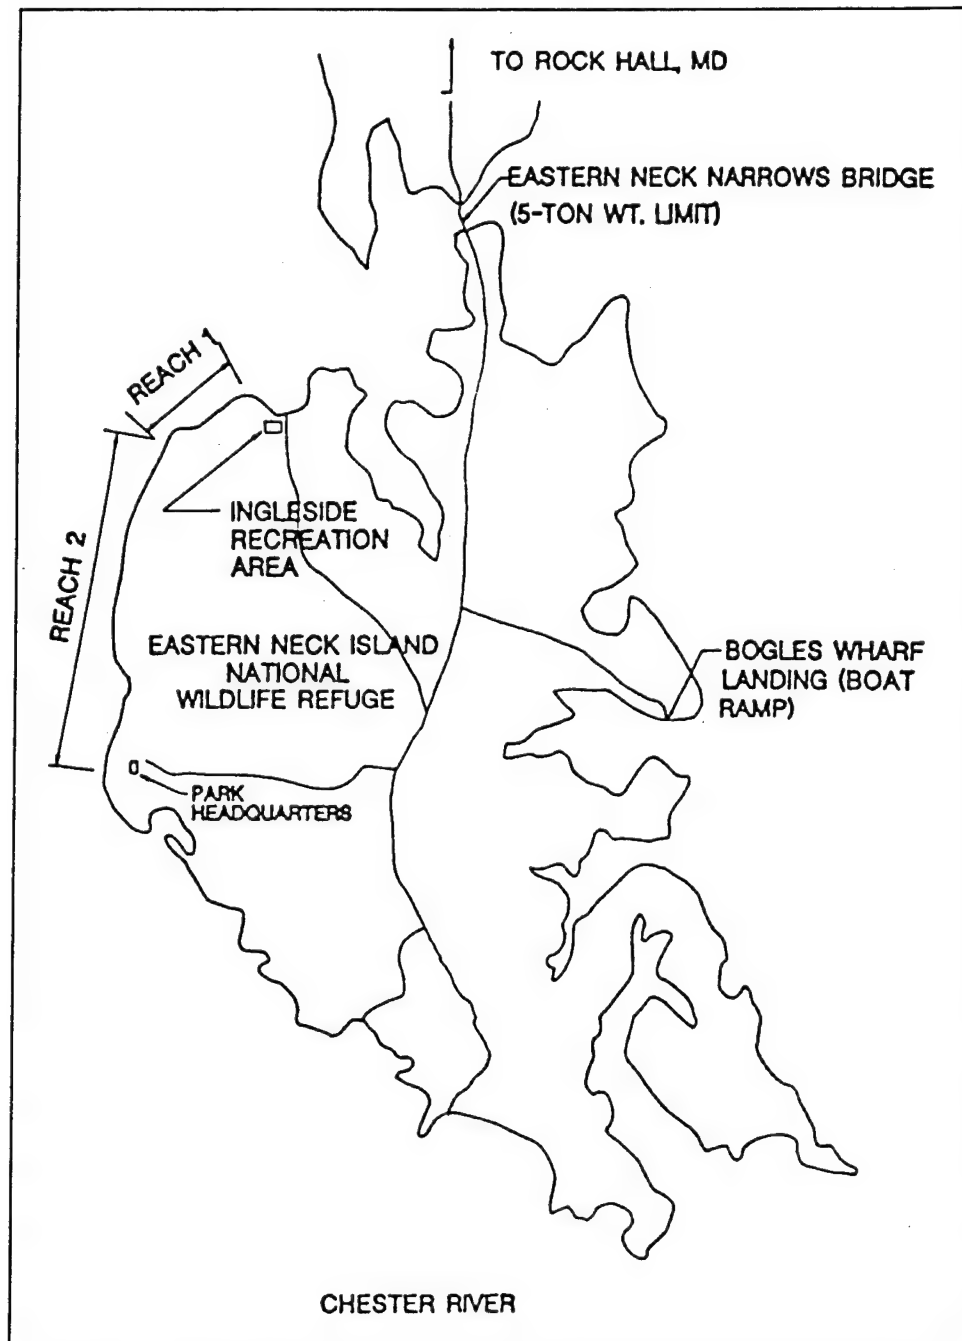
Figure 2. Site map

In 1989, the U.S. Congress appropriated funds to design and construct shoreline erosion control measures on the refuge western shore. Two reaches of the western shoreline were identified as exhibiting the highest rates of erosion (Figure 2). Reach 1 extends 304 m from Ingleside picnic area to the northwest corner of the island. Reach 2 extends 1,733 m from the northwest corner to Wickes Beach. After several erosion control alternatives were evaluated, a series of stone (riprap), offshore breakwaters was selected as the most environmentally sound approach. Construction began in March of 1992.

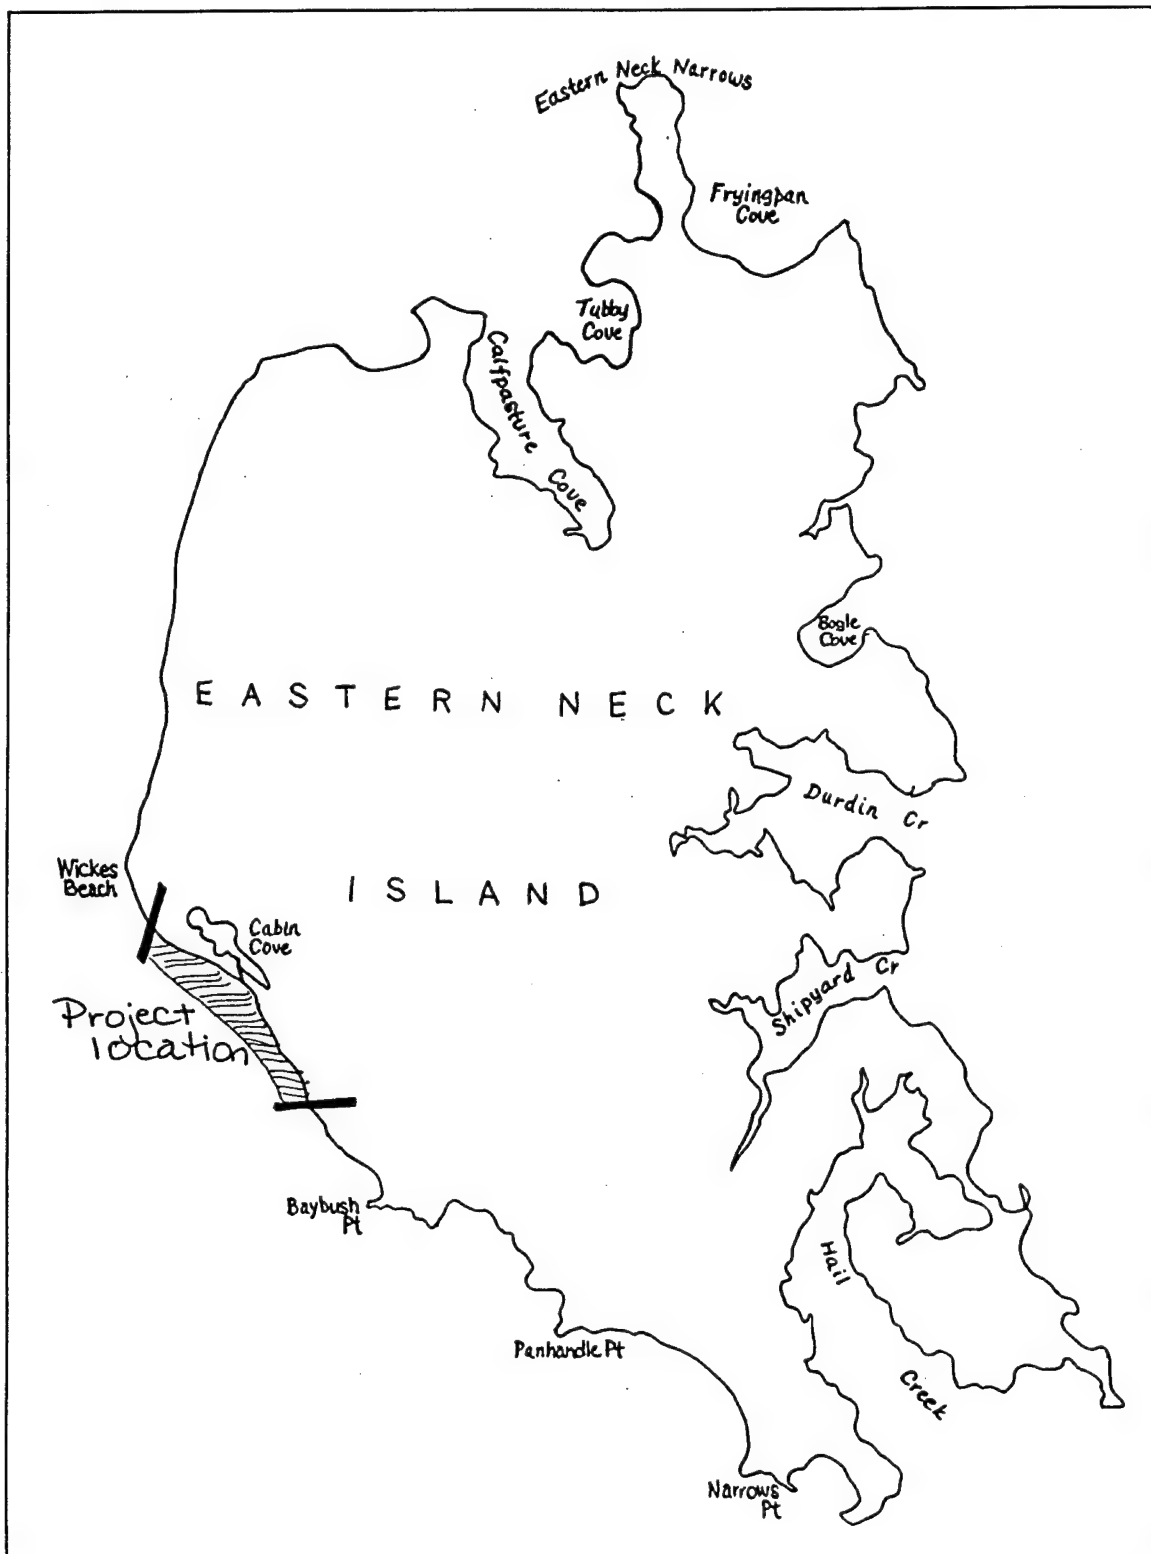
Figure 3. Study area

Because bids were more favorable than predicted, additional funds during July of 1992 were available from the original \$2.9 million appropriation. It was decided to extend shoreline protection immediately south of Reach 2, to include Wickes Beach and Cabin Cove areas. Cabin Cove encompasses the present study area (Figure 3).

Extended shoreline protection in the study area consists of five stone breakwaters (constructed of 1.5- to 3-ton² stones) located a maximum of 122 m offshore in depths of 0.76 m mean low water (mlw), and oriented parallel to the shoreline. Breakwaters are trapezoidal in cross section, 30.4 m long, with a top height of 1 m above mean high water (mhw). Including a revetment tied into the shoreline and 15-m breaks between breakwaters, the project provides approximately 608 m of additional shoreline protection.

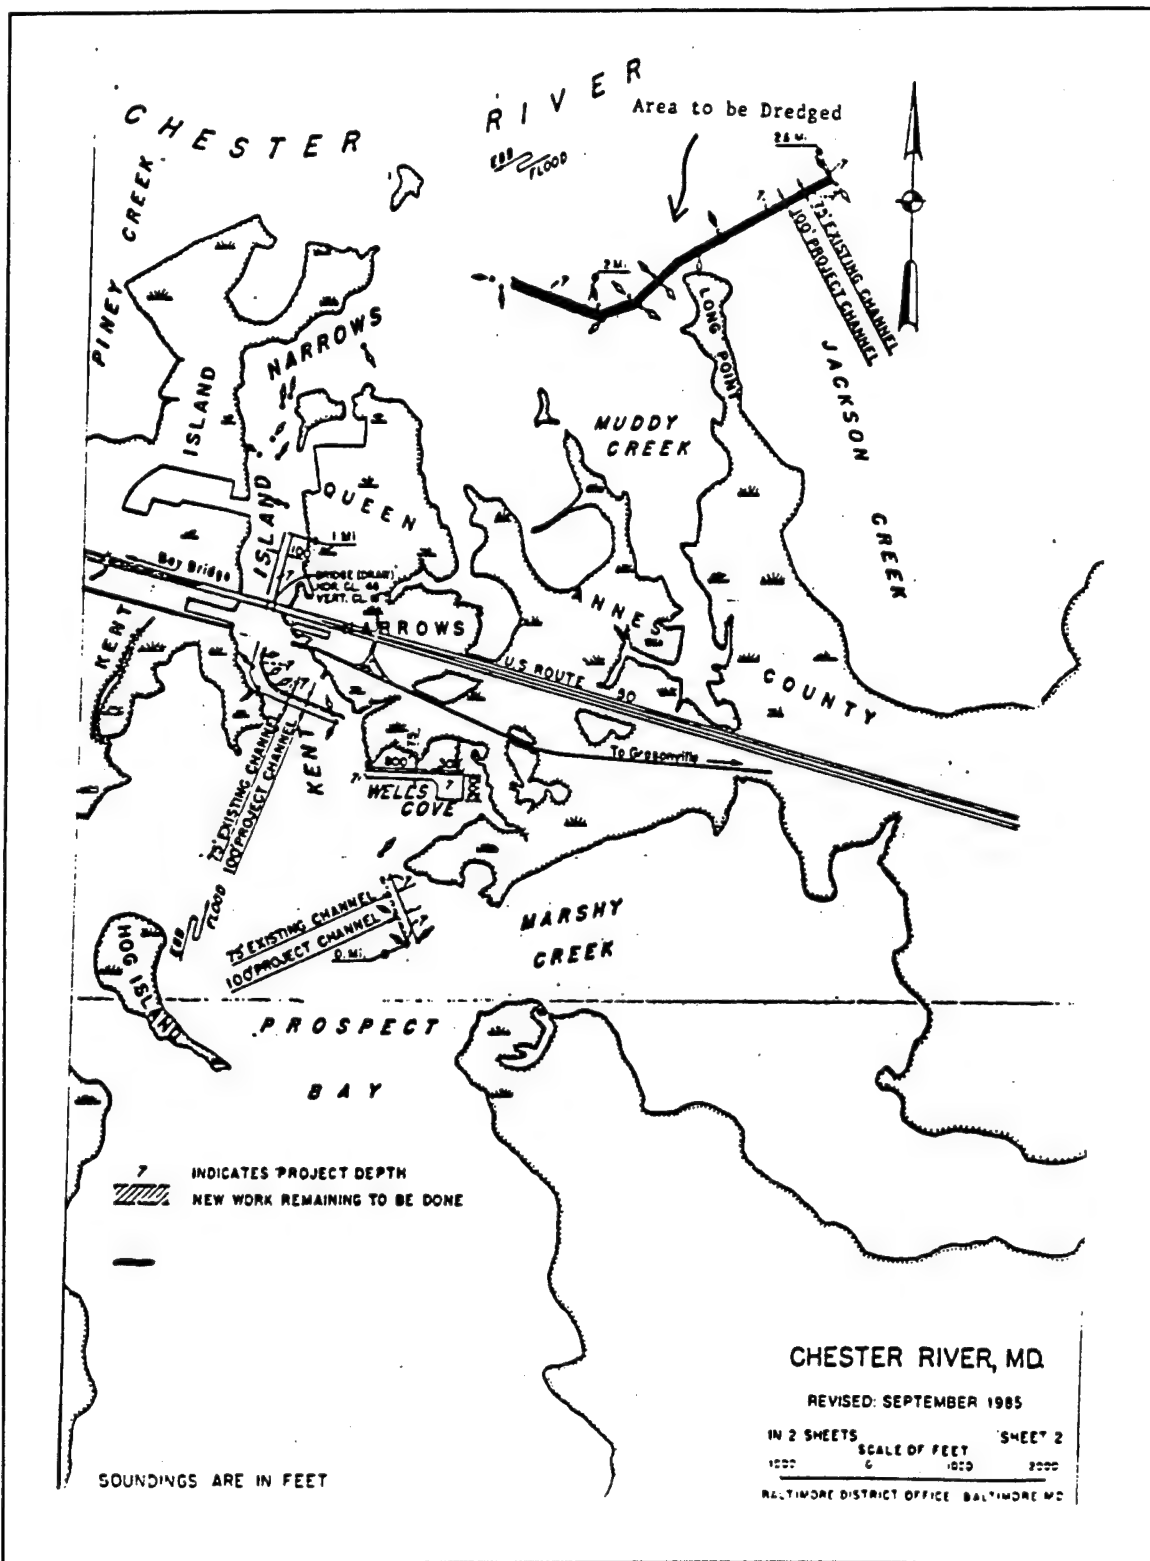
Figure 4. Location of Kent Narrows and Chester River Channel

The Chester River channel is located at the northern entrance to Kent Narrows, approximately 7.2 km south of the refuge (Figures 1 and 4). Kent Narrows is used as a shortcut by boaters between popular anchorages found on the Chester River and tributaries to Eastern Bay, and is one of the busiest thoroughfares in the Maryland portion of Chesapeake Bay.

The Long Point section of the Chester River channel had shoaled to controlling depths averaging 0.6 to 1.5 m, hindering navigational access in and out of Kent Narrows. Maintenance dredging reestablished a channel 2.1 m deep along approximately 1,611 m of the 23-m-wide channel. Hydraulic dredging generated approximately 34,380 cu m of predominantly fine grained sand.

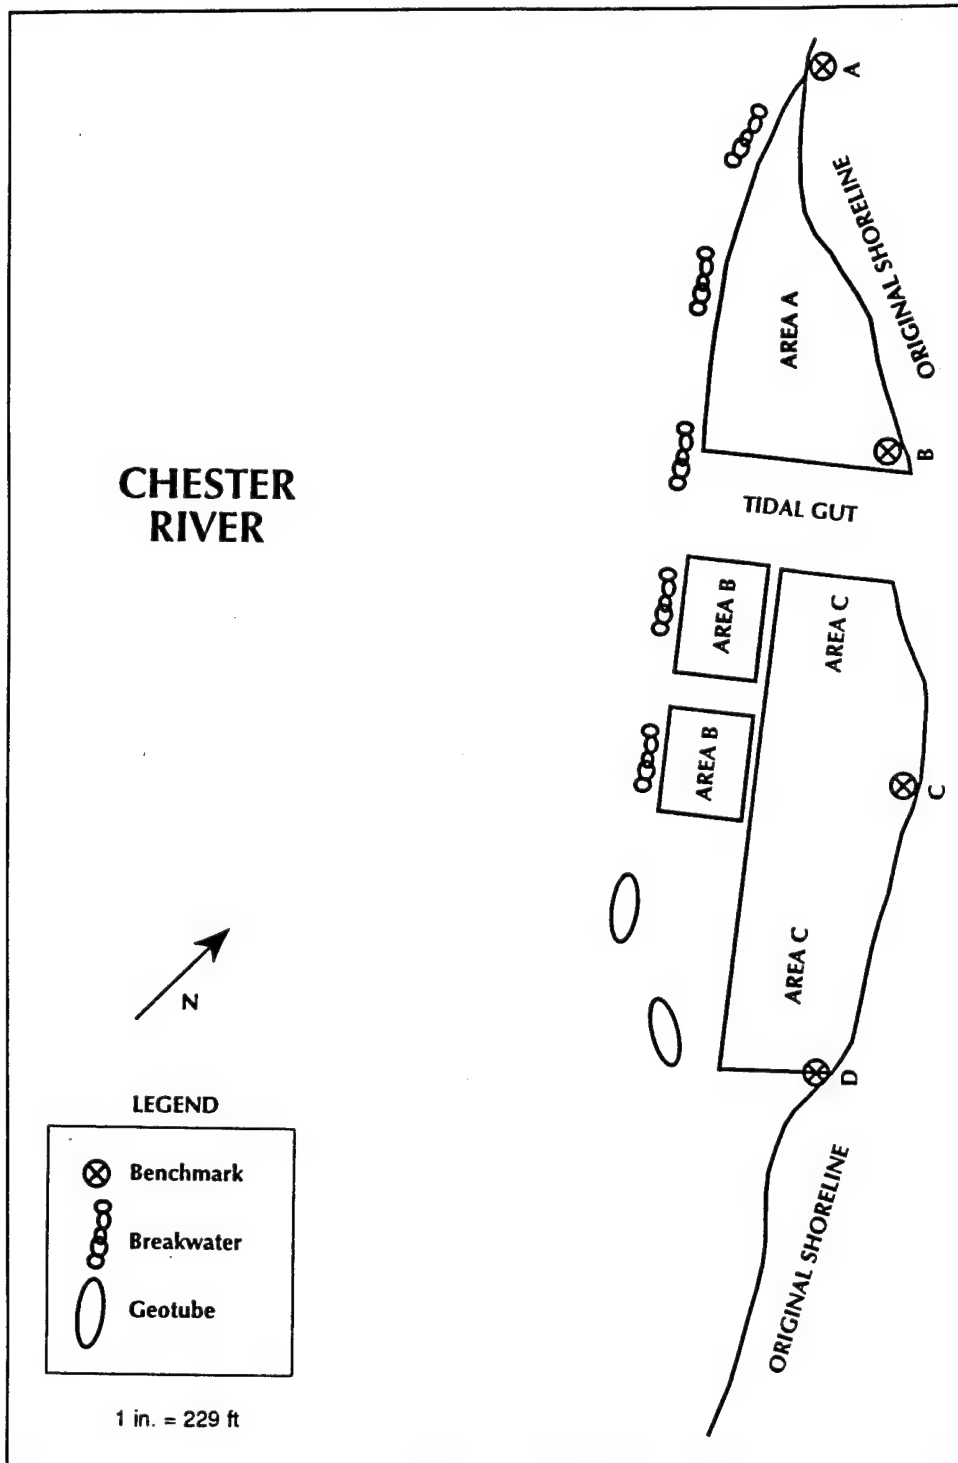
Figure 5. Dredged material deposition areas

Approximately 34,380 cu m of predominantly fine grained sand was hydraulically deposited landward of the five offshore breakwaters in June 1993. Material was deposited in three areas, designated Area A, Area B, and Area C (Figure 5). In order to assure tidal inundation to the tidal pond and associated estuarine emergent wetland complex, material was not placed in front of the tidal gut. Material was mounded to 0.304 m above mhw along the original shoreline in Areas A and C, allowed to dewater, and graded on a 1V:10H slope to mlw. Material deposited in Area B was mounded to 0.304 m above mhw along the breakwaters, and graded on a 1V:10H slope toward Area C. Areas A, B, and most of C are protected from the northwest fetch (severe winter storm fetch) by breakwaters or Geotubes. The lower (southern) fifth of Area C is exposed to the northwest fetch.

In addition to breakwaters, two Geotubes were deployed and filled with dredged material. Geotubes (Nicolon Corporation, Norcross, GA) are fabricated from geotextile fabric sewn into a tube. Pores in the fabric are sized to allow retention of hydraulically transported dredged material, and allow water drainage during tube filling. Geotubes are fitted with several filling portals that can be connected to a hydraulic pipeline. Each Geotube measured 0.9 m in diameter by 30.4 m long. After filling and settling, Geotubes had an elliptical cross section that provided 0.46 m effective height.

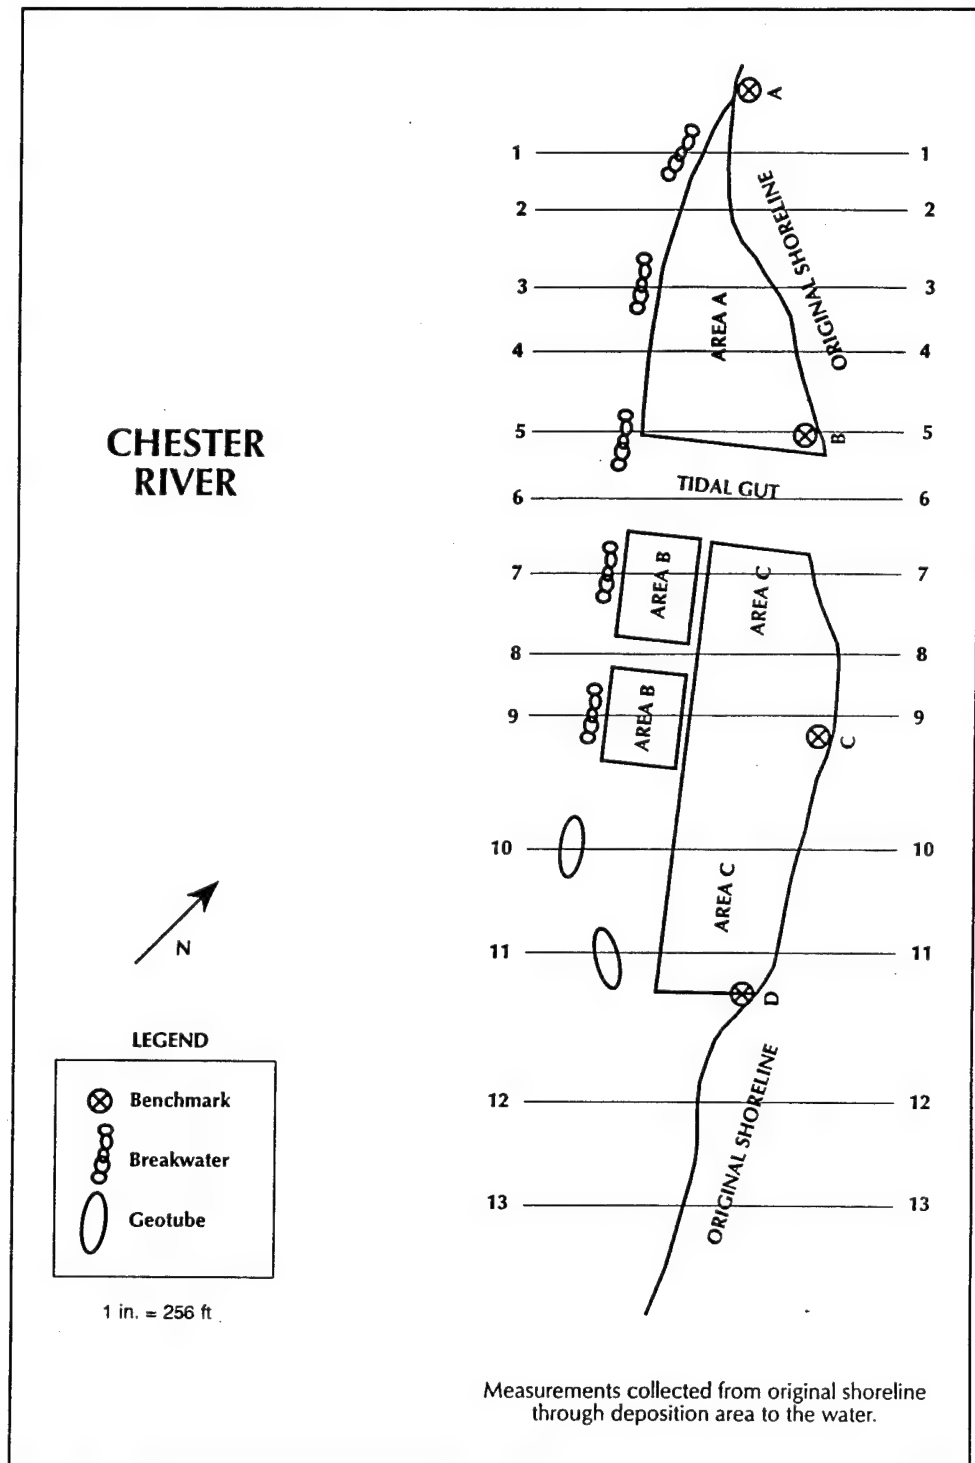
Figure 6. Monitoring transect locations

Monitoring data were collected along a series of 13 transects, oriented perpendicular to the shoreline (Figure 6). Transects were located to alternate between breakwater and open water. All transects except Transect 6 (representing the tidal creek) and Transects 12 and 13 (representing controls), were located to cross all vegetation zones in the planted wetland.

Transect lengths ranged from a minimum of 18 m at Transect 1 to a maximum of 108 m at Transect 9. Spacings of transects ranged from a minimum of 15 m between Transects 12 and 13 to a maximum of 68.4 m between Transects 11 and 12. Most transects were approximately 30.4 m apart.

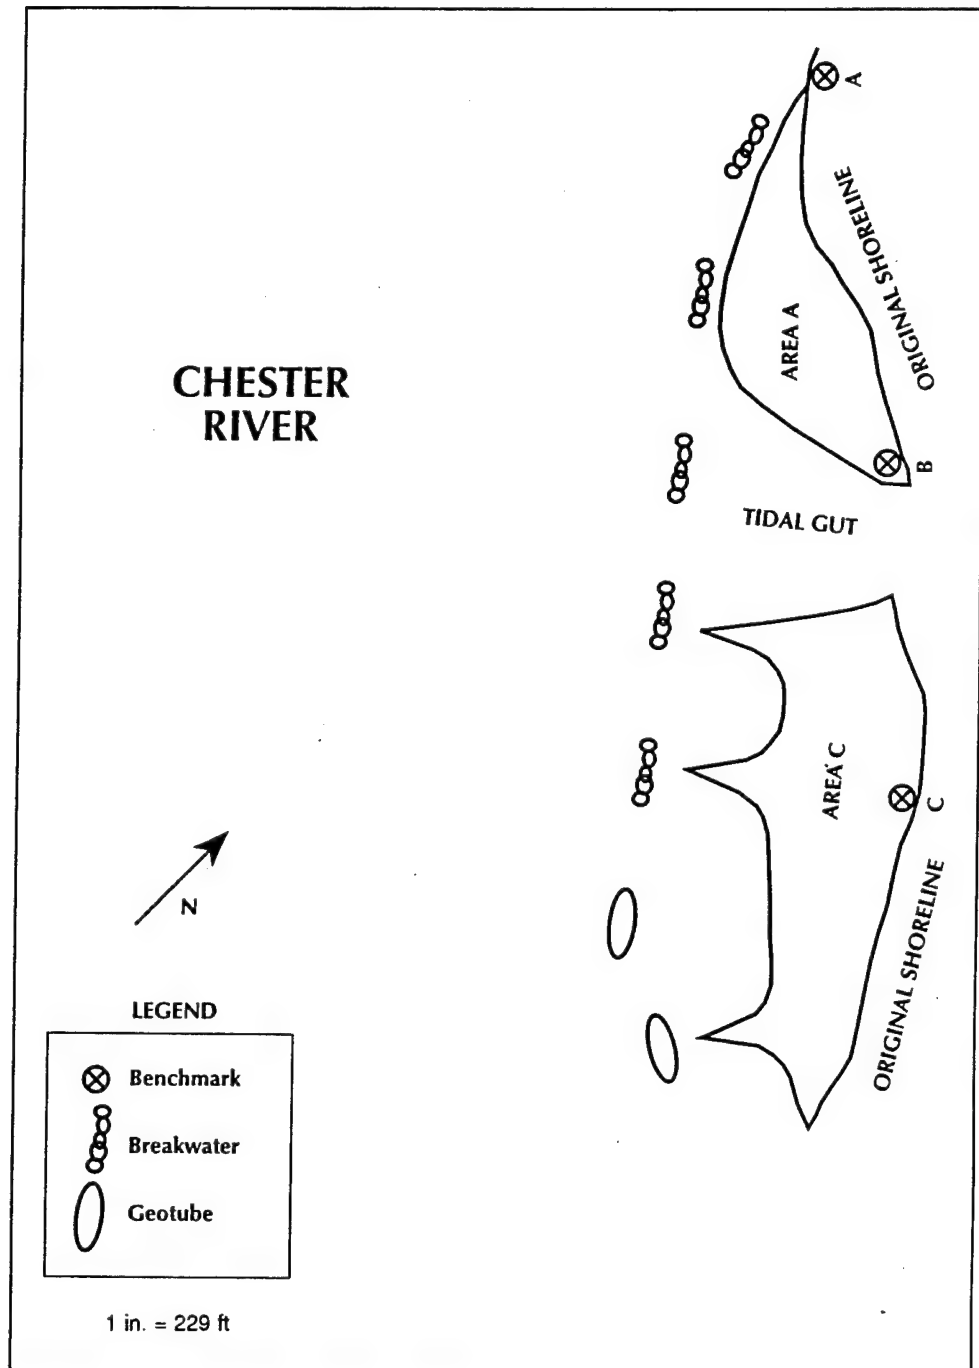
Figure 7. 1994 shoreline configuration

Unstable shoreline conditions were observed throughout the study period at Transects 5, 6, and 7 in the area of the tidal gut. Prior to dredged material placement, this area exhibited dynamic shoreline conditions, with strong ebb tide flows exiting the gut. These conditions persisted during the study period, and caused dredged material losses on the gut side of Areas A and C.

The appearance of the exposed original shoreline in the vicinity of Transects 12 and 13 suggests erosion is continuing. At the time of submission

of this report, all other original shoreline sections within the study area were stable.

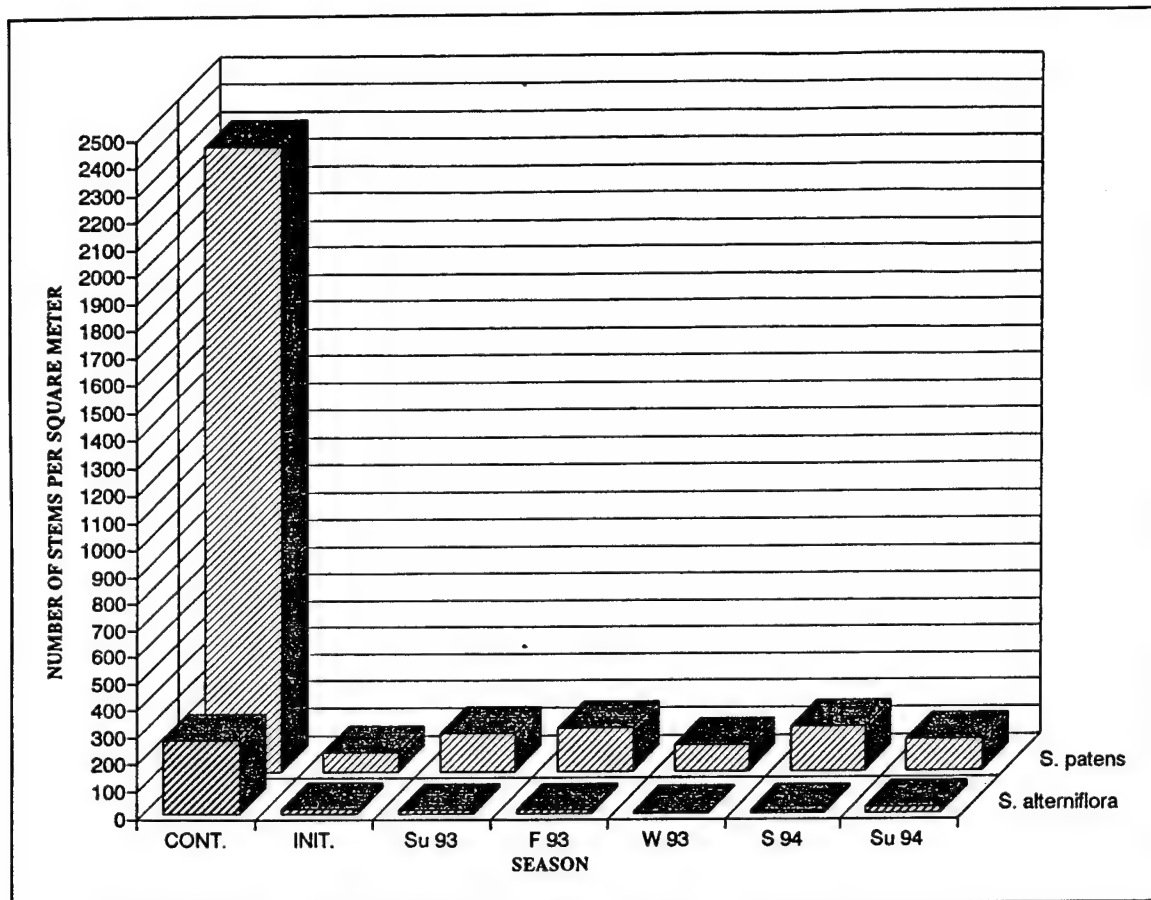
Figure 8. Mean stem density of planted grasses in 1993-1994

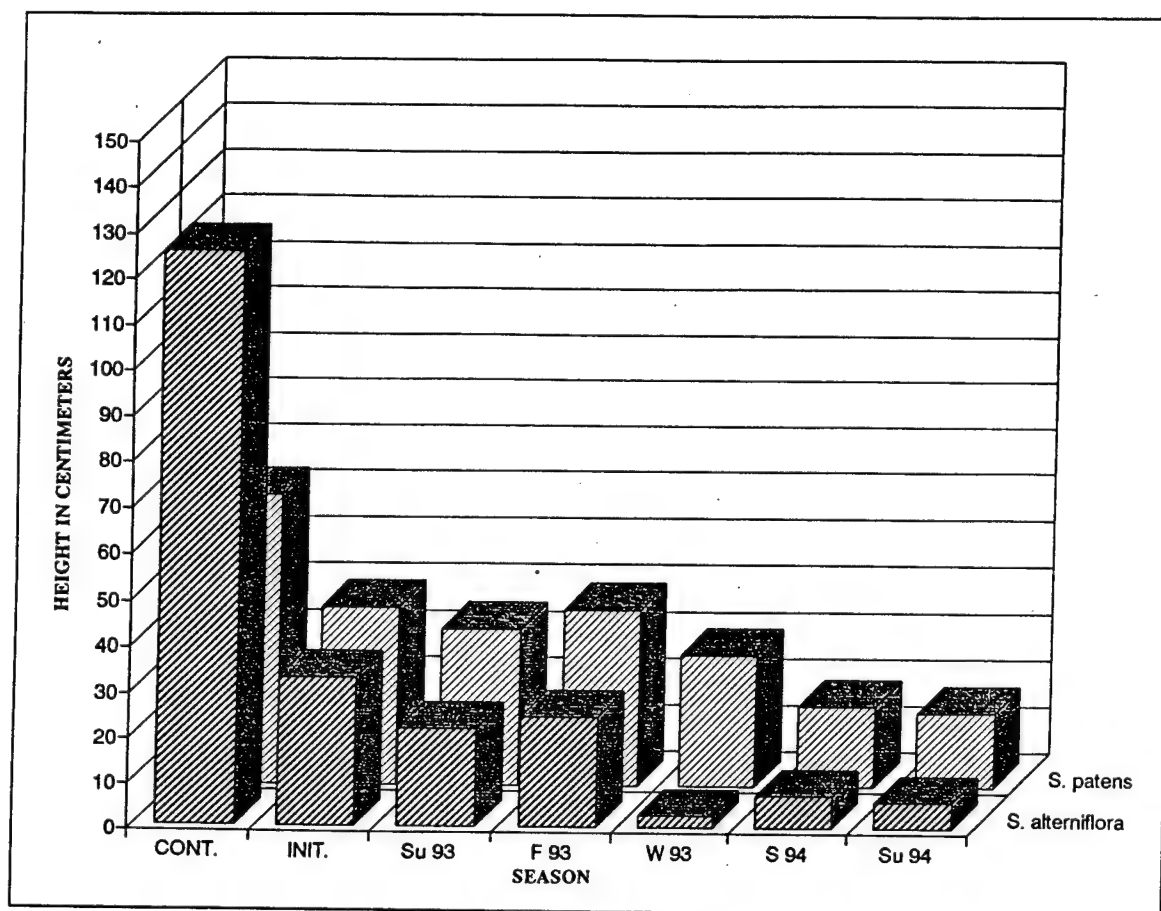
Figure 9. Mean stem height of planted grasses in 1993-1994

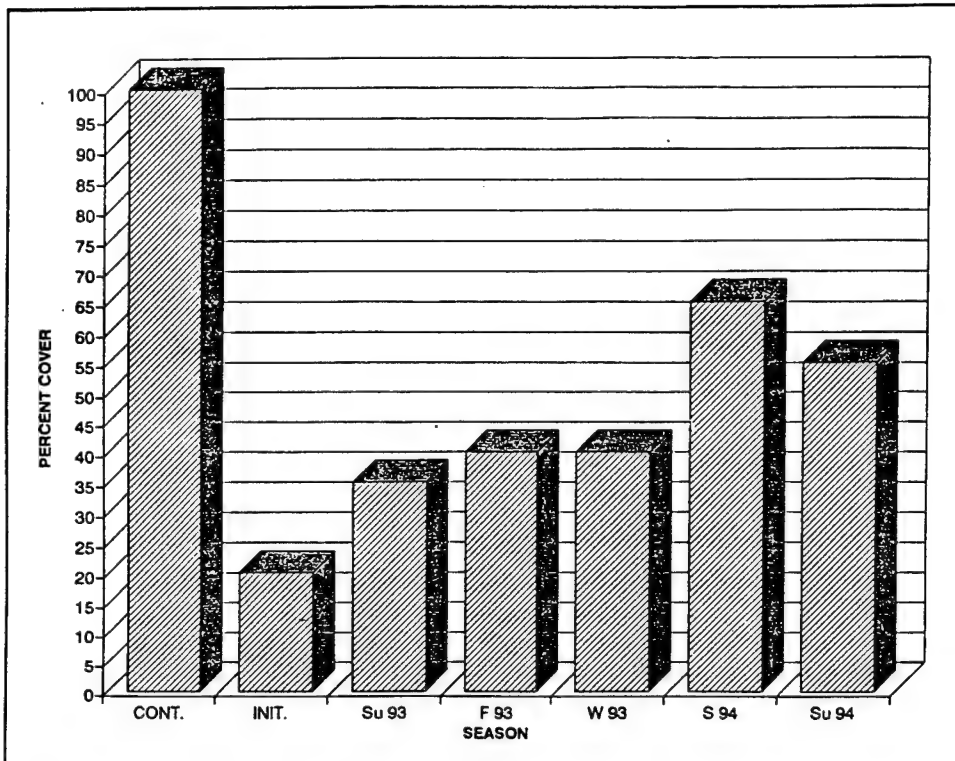
Figure 10. Percent cover of vegetational quadrats in 1993-1994

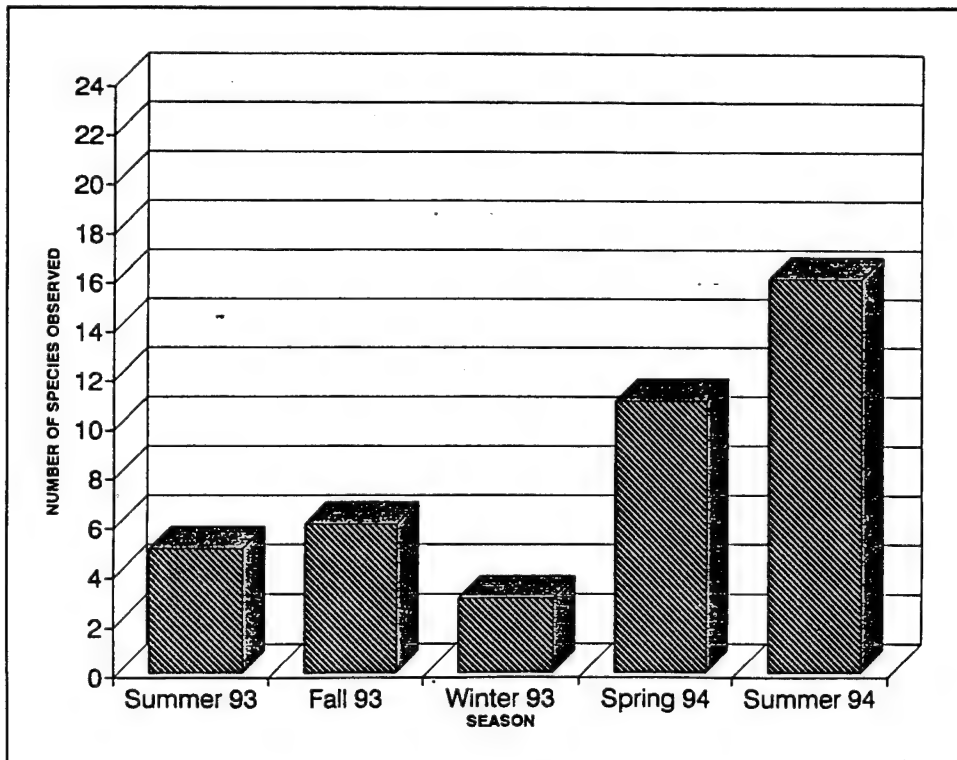
Figure 11 depicts the number of plant species observed during the course of the study period. At the beginning the site was rapidly colonized by sea rocket (*Cakile edunata*) and common reed. During the first summer, all common reed invasion was by rhizome extension. During sampling, all rhizome growth encountered was severed from the supporting *Phragmites* stands. Common reed was a problem the second summer (after herbicide treatment) due to viable seed dispersal. By the end of the second summer the site supported 16 wetland and dune species (Table 4). By frequency of occurrence common reed constituted 1.5 percent, and was treated with herbicide again.

Figure 11. Number of plant species observed in wetland creation study site

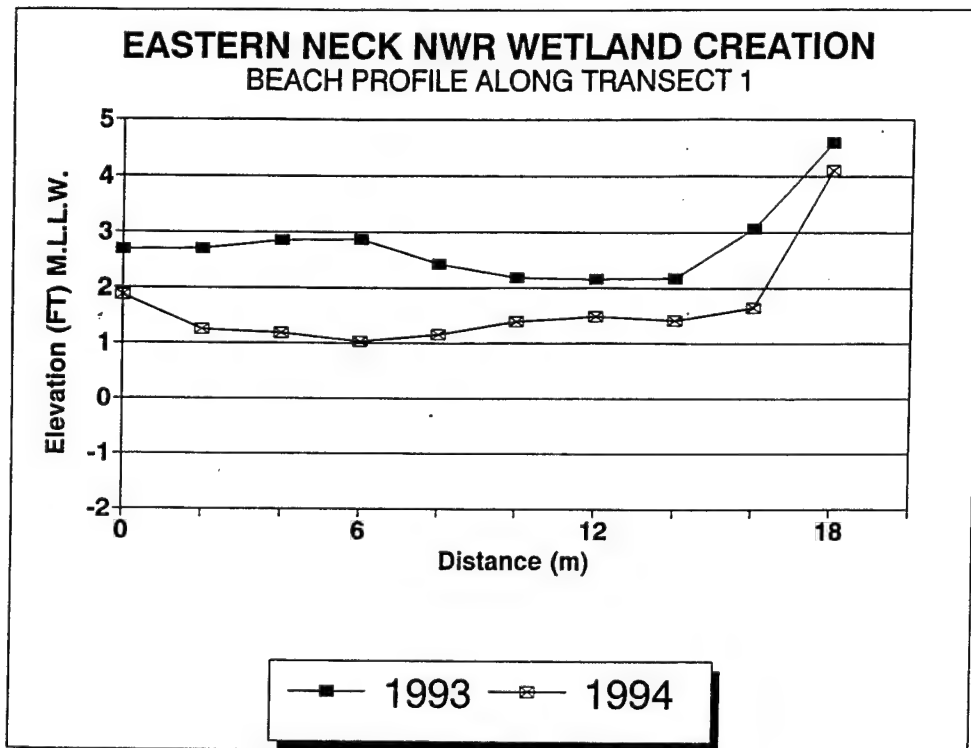
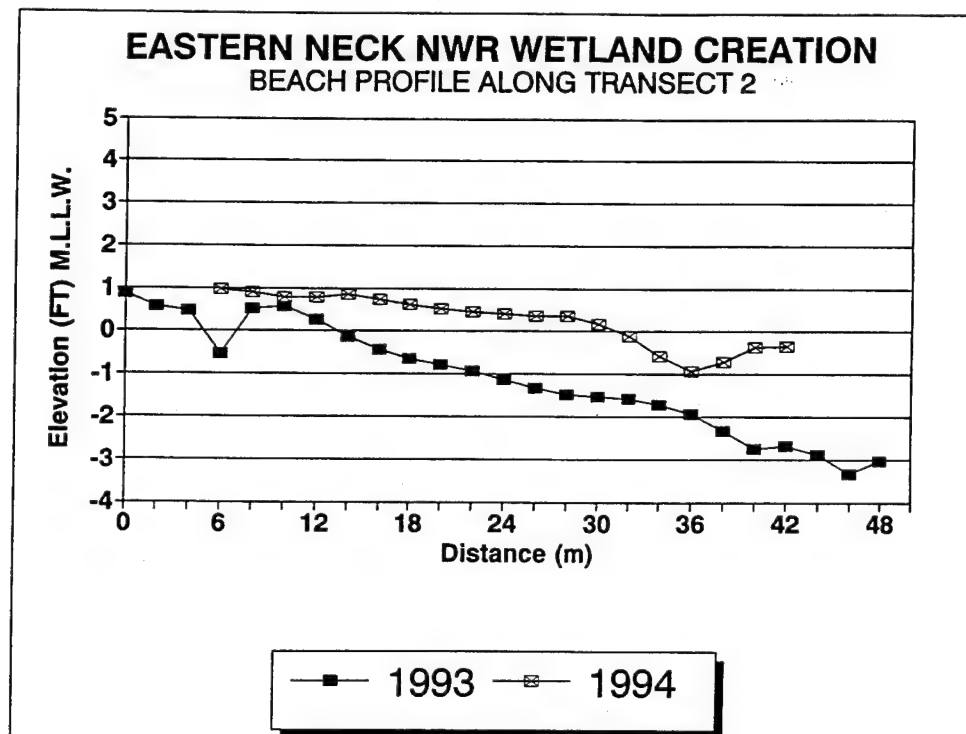
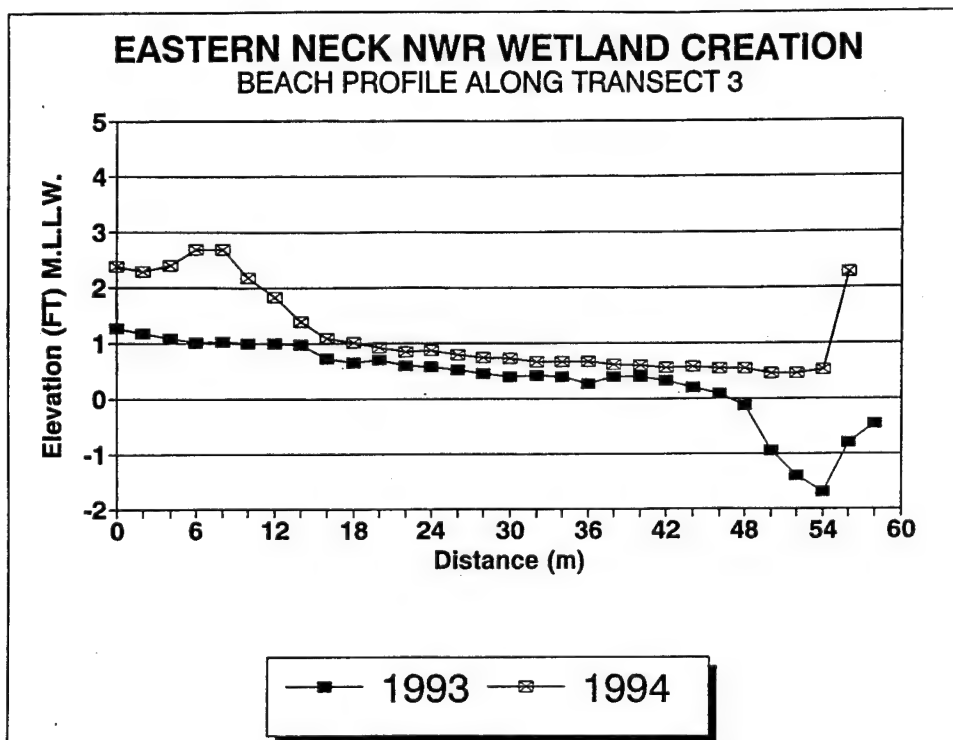
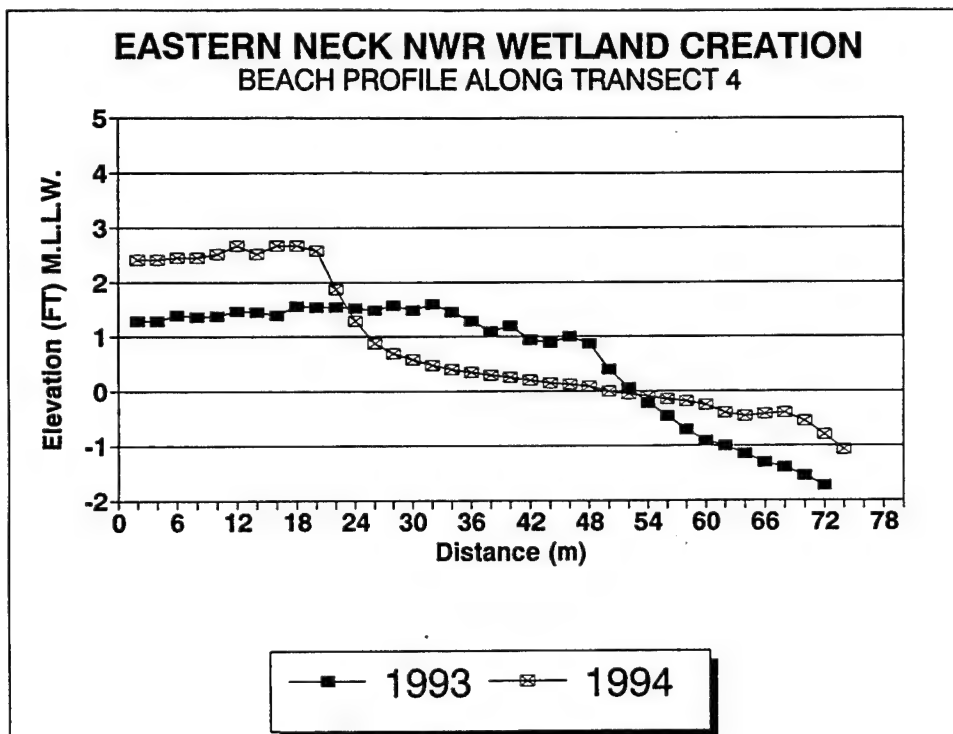
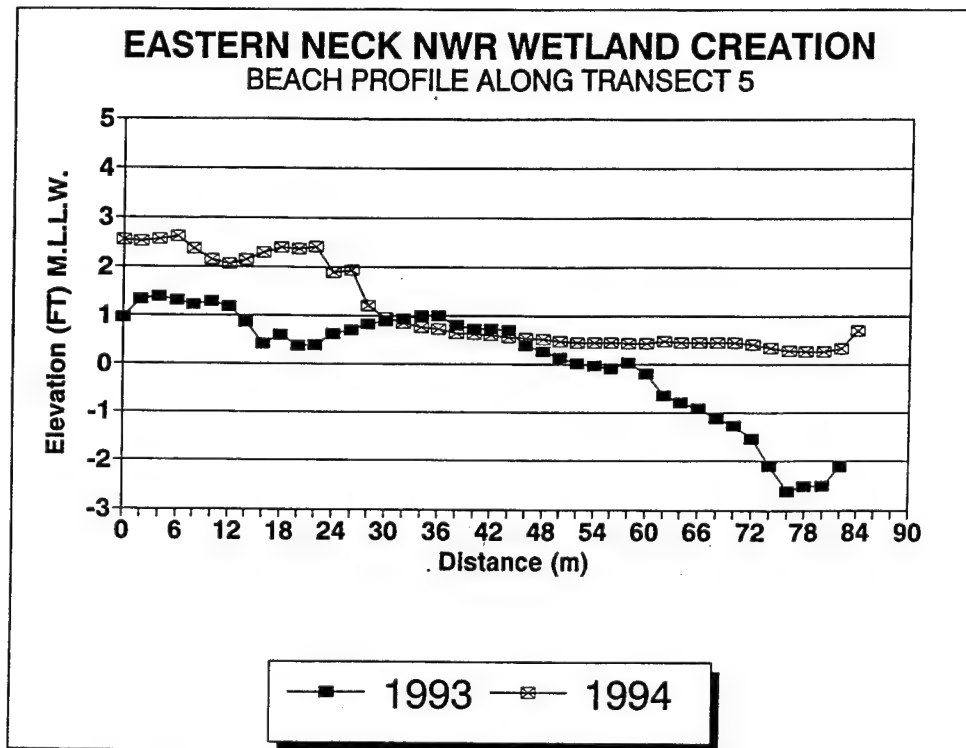
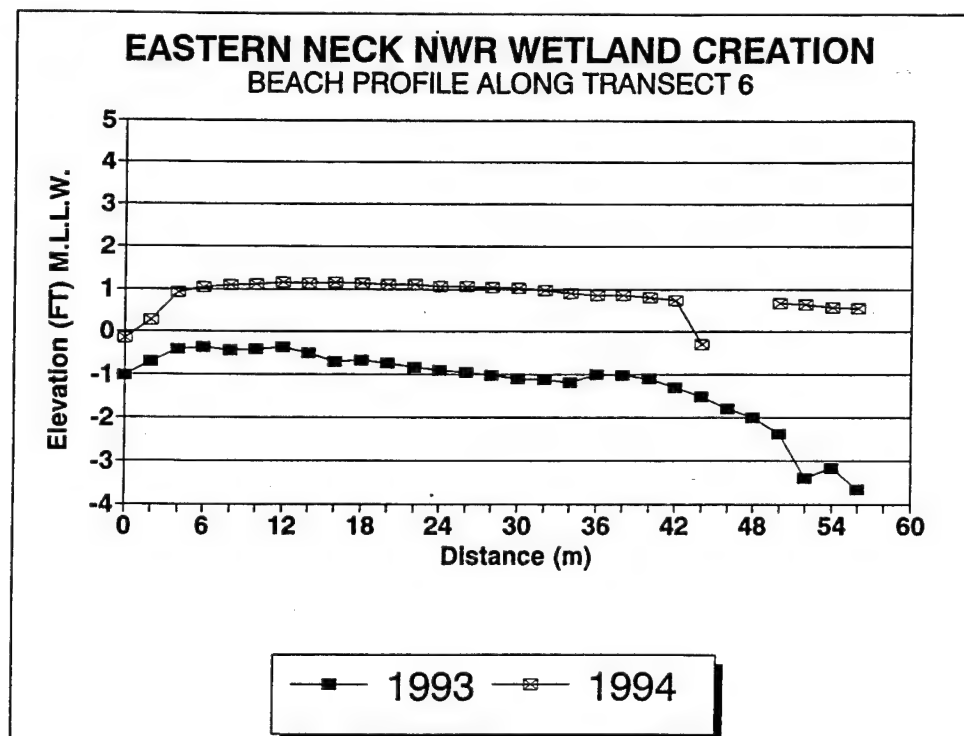
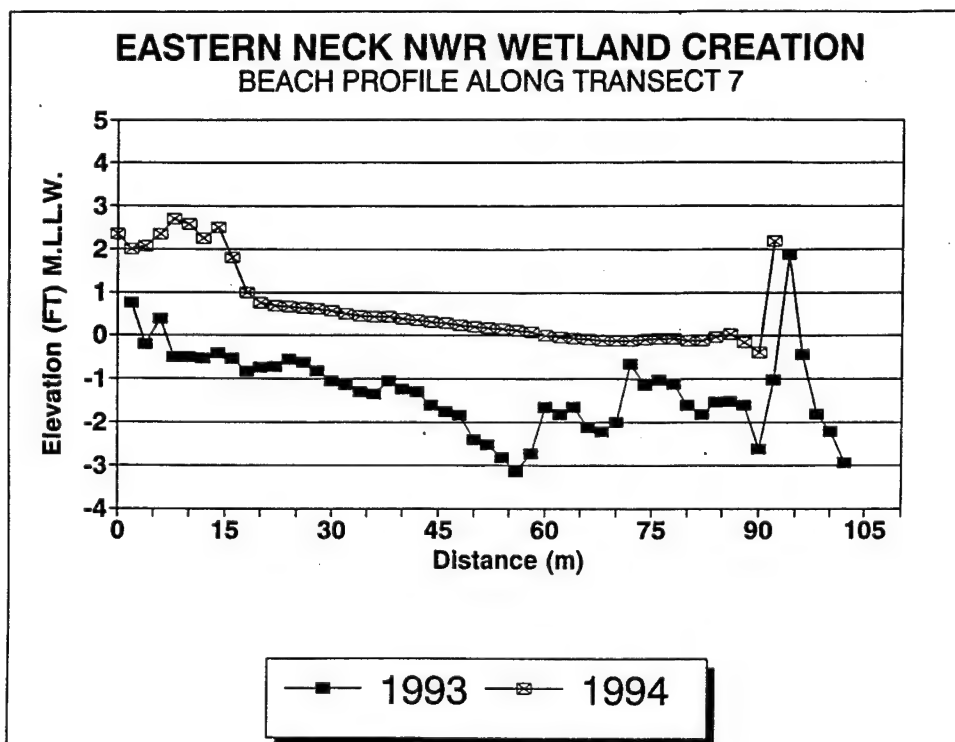
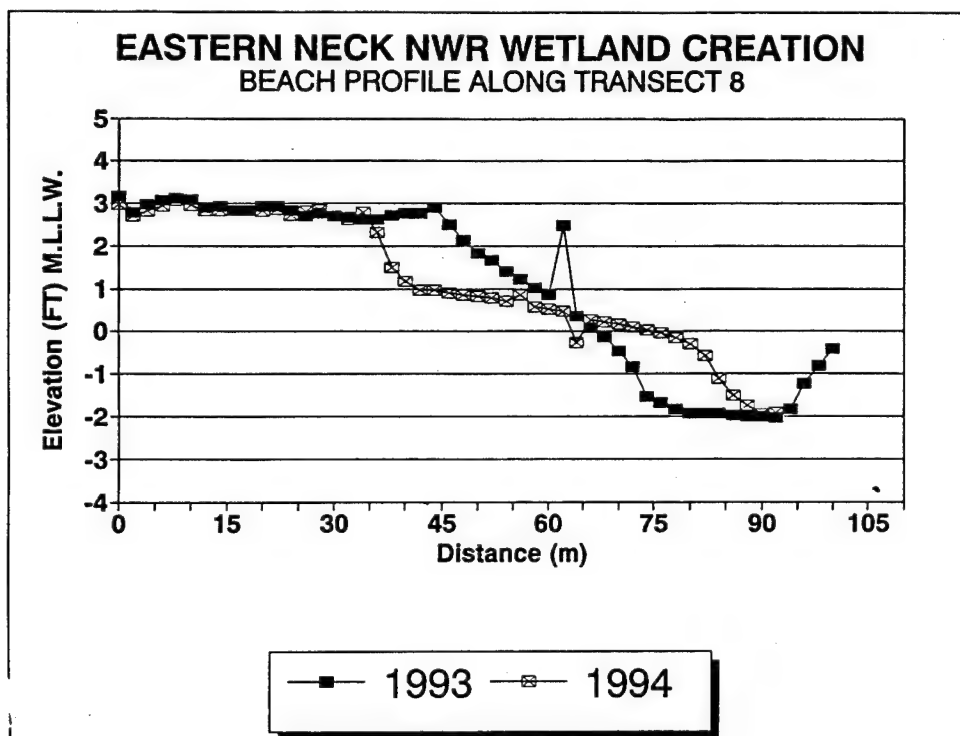
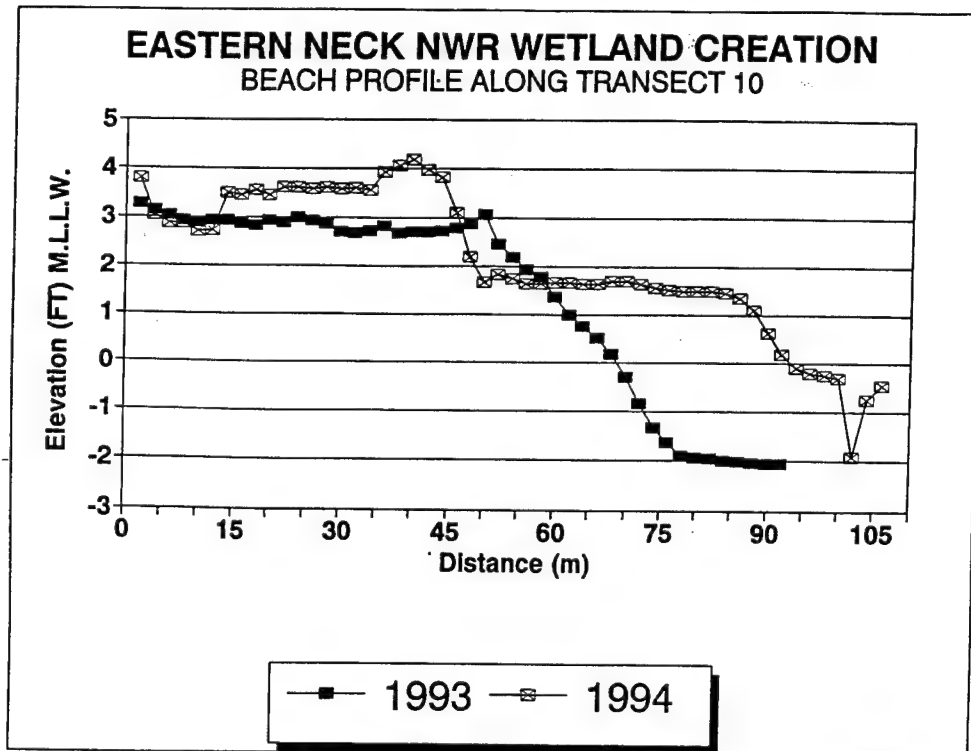
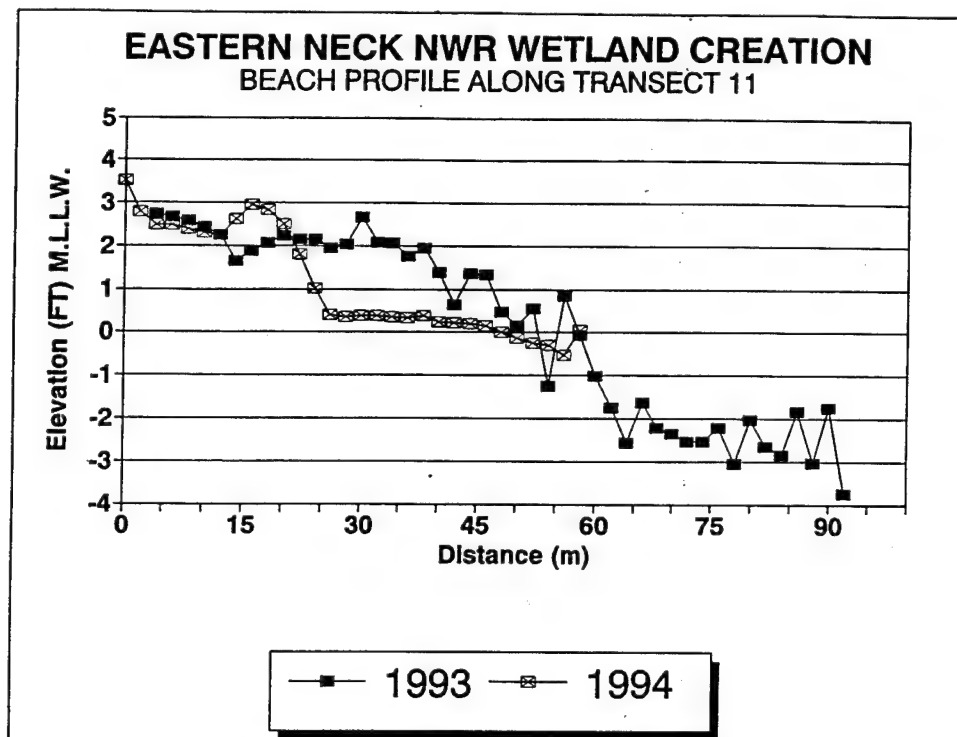
Dredged material beach profiles are presented in Appendix A. Elevations were taken in the summer of 1993 immediately after dredged material placement, and again in the summer of 1994. Measurements are presented by transect. Benchmark D was lost to erosion during the winters of 1993 and 1994; therefore, profiles are missing for Transects 12 and 13. Data are lacking for Transect 9.
